# Manhole Inspection Summary

Manhole # S17Y\_\_012MH

**Inspection** ☐ Is Incomplete Rating: **3) Fair**

**Location** Address: **2536 washington-james alley**

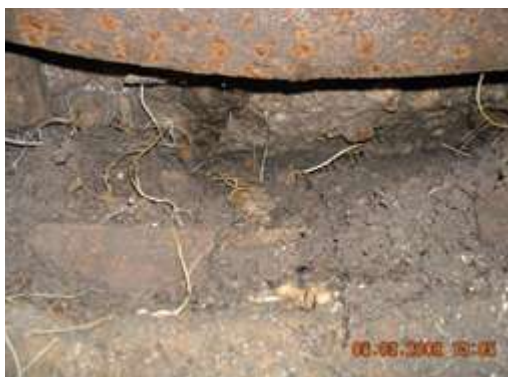
Defect 7

Condition: ☐ Sound ☐ Cracked ☒ **Root Intrusion** ☒ **Loose Brick** ☒ **Deteriorated**

deteriorated chimney

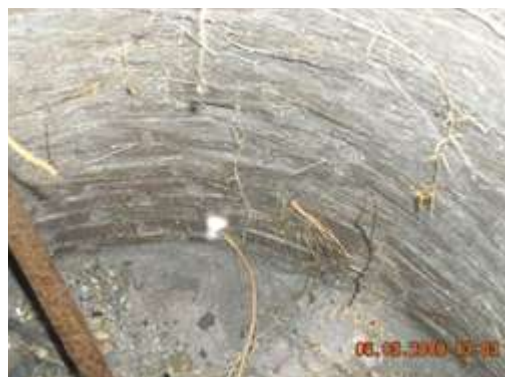
Defect 6

Condition: ☐ Sound ☐ Cracked ☒ **Root Intrusion** ☐ Loose Brick ☐ Deteriorated

root intrusion @ barrel wall

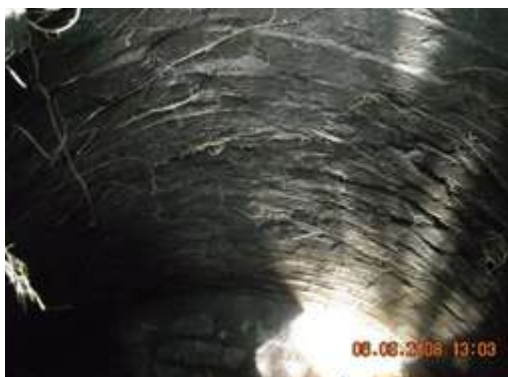
Defect 5

Condition: ☐ Sound ☐ Cracked ☒ **Root Intrusion** ☐ Loose Brick ☐ Deteriorated

root intrusion @ corbel wall

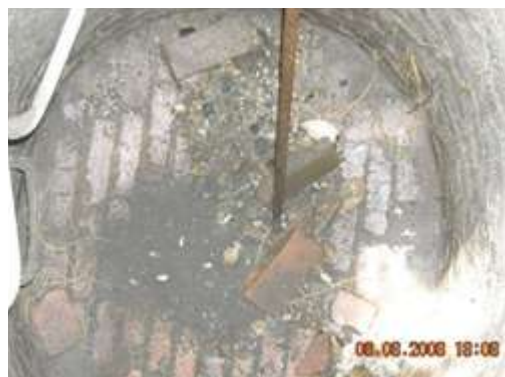
Defect 4

Condition: ☐ Sound ☐ Cracked ☐ Root Intrusion ☐ Deteriorated ☐ Leaks ☒ **Debris**

debris in terminal channel

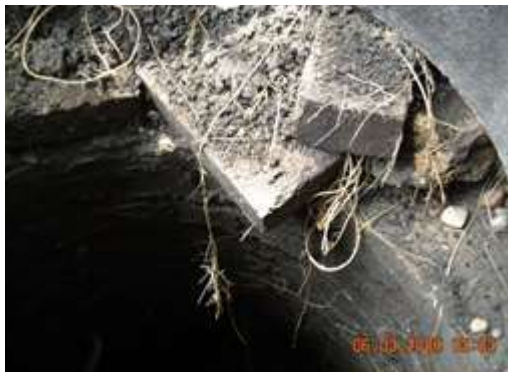
Defect 3

loose chimney bricks

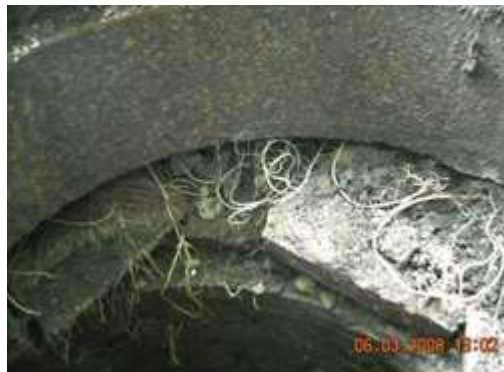
Defect 2

root intrusion @ chimney/frame joint

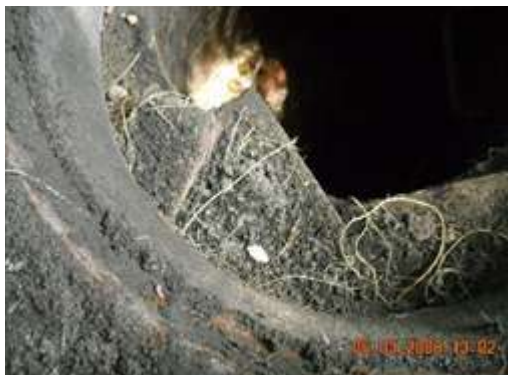
Defect 1

Offset: **5** (in.)

frame offset

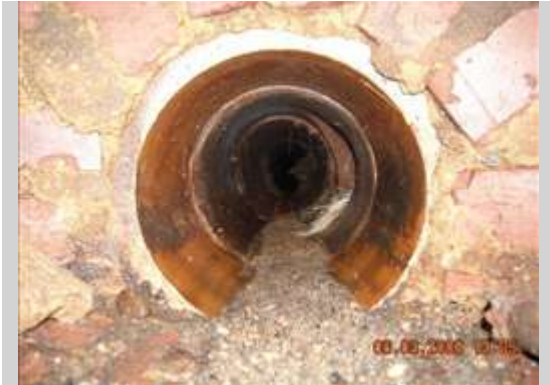
12 O'Clock Outflow

Deposits: ☐ None ☒ **Mud** ☐ Sludge ☐ Debris ☐ Grease

Silt Depth: **1** (in.) Deposits Extent: **Light**
